Limited Visual Dam Safety Inspection Summary Report

MA-144

Maui County Water

Limited Visual Dam Safety Inspection Conducted on: 07 April 2006

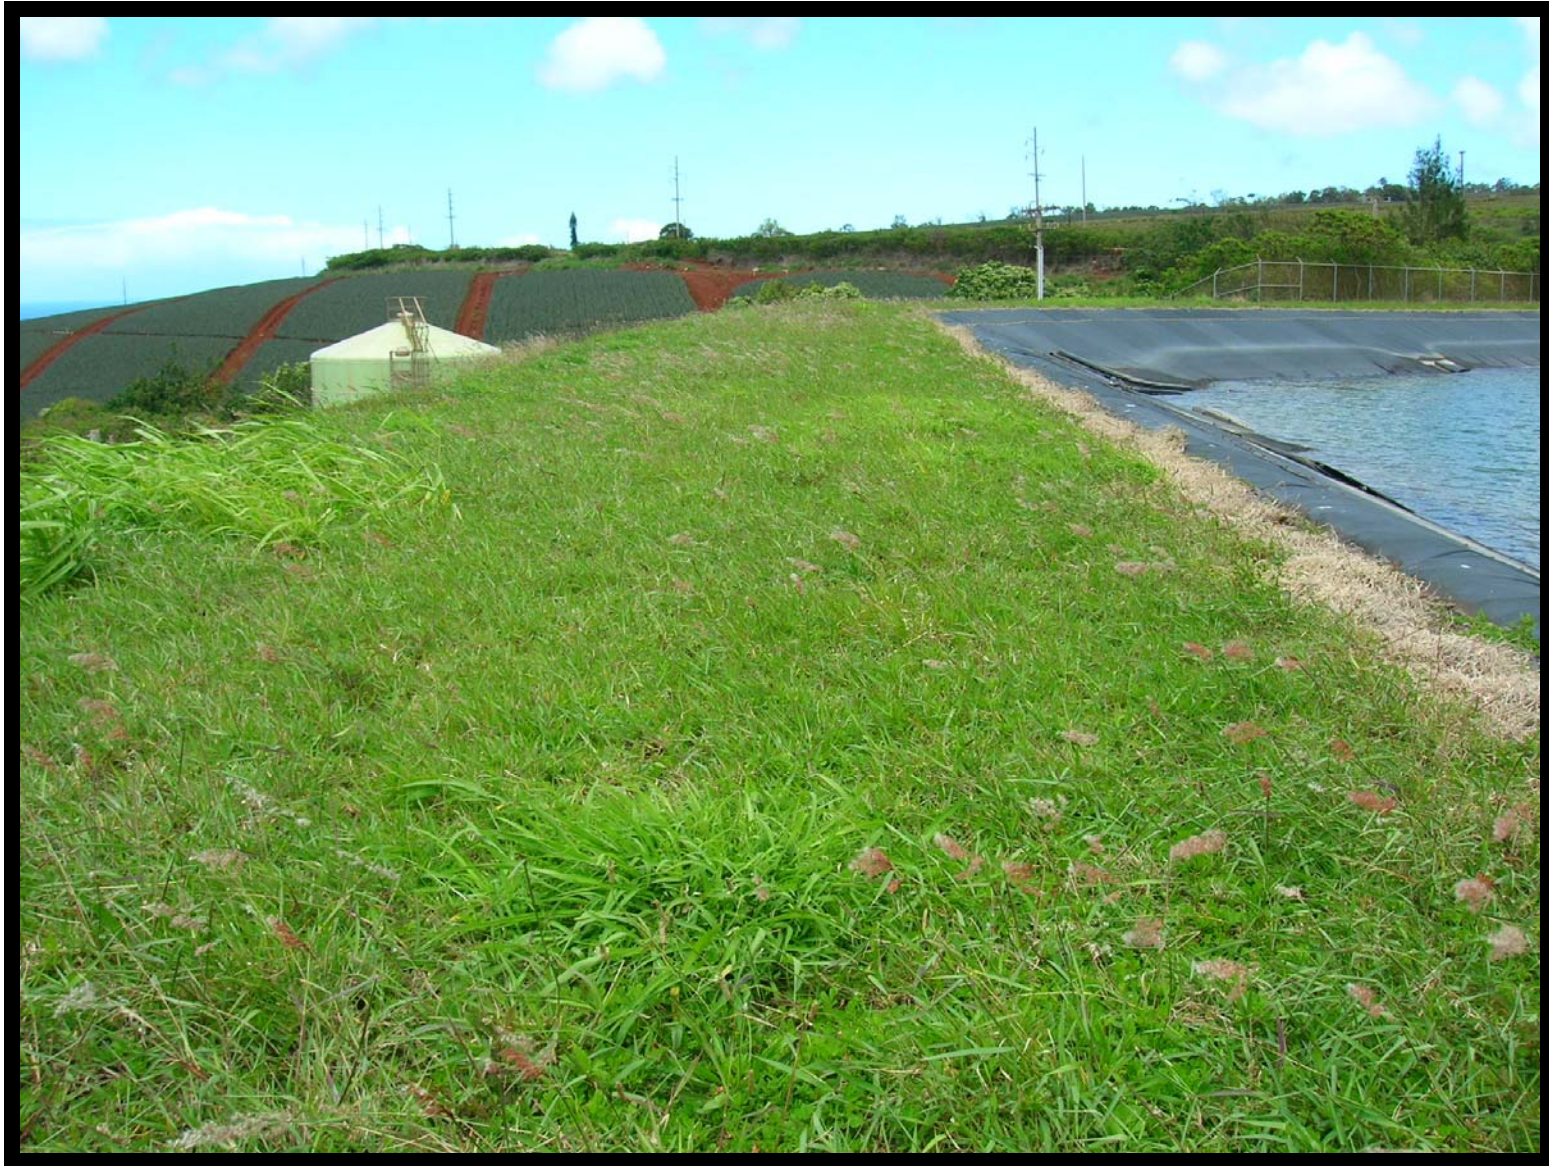
144 View of the crest. The upstream slope is to the right.
Short grass covers the crest.

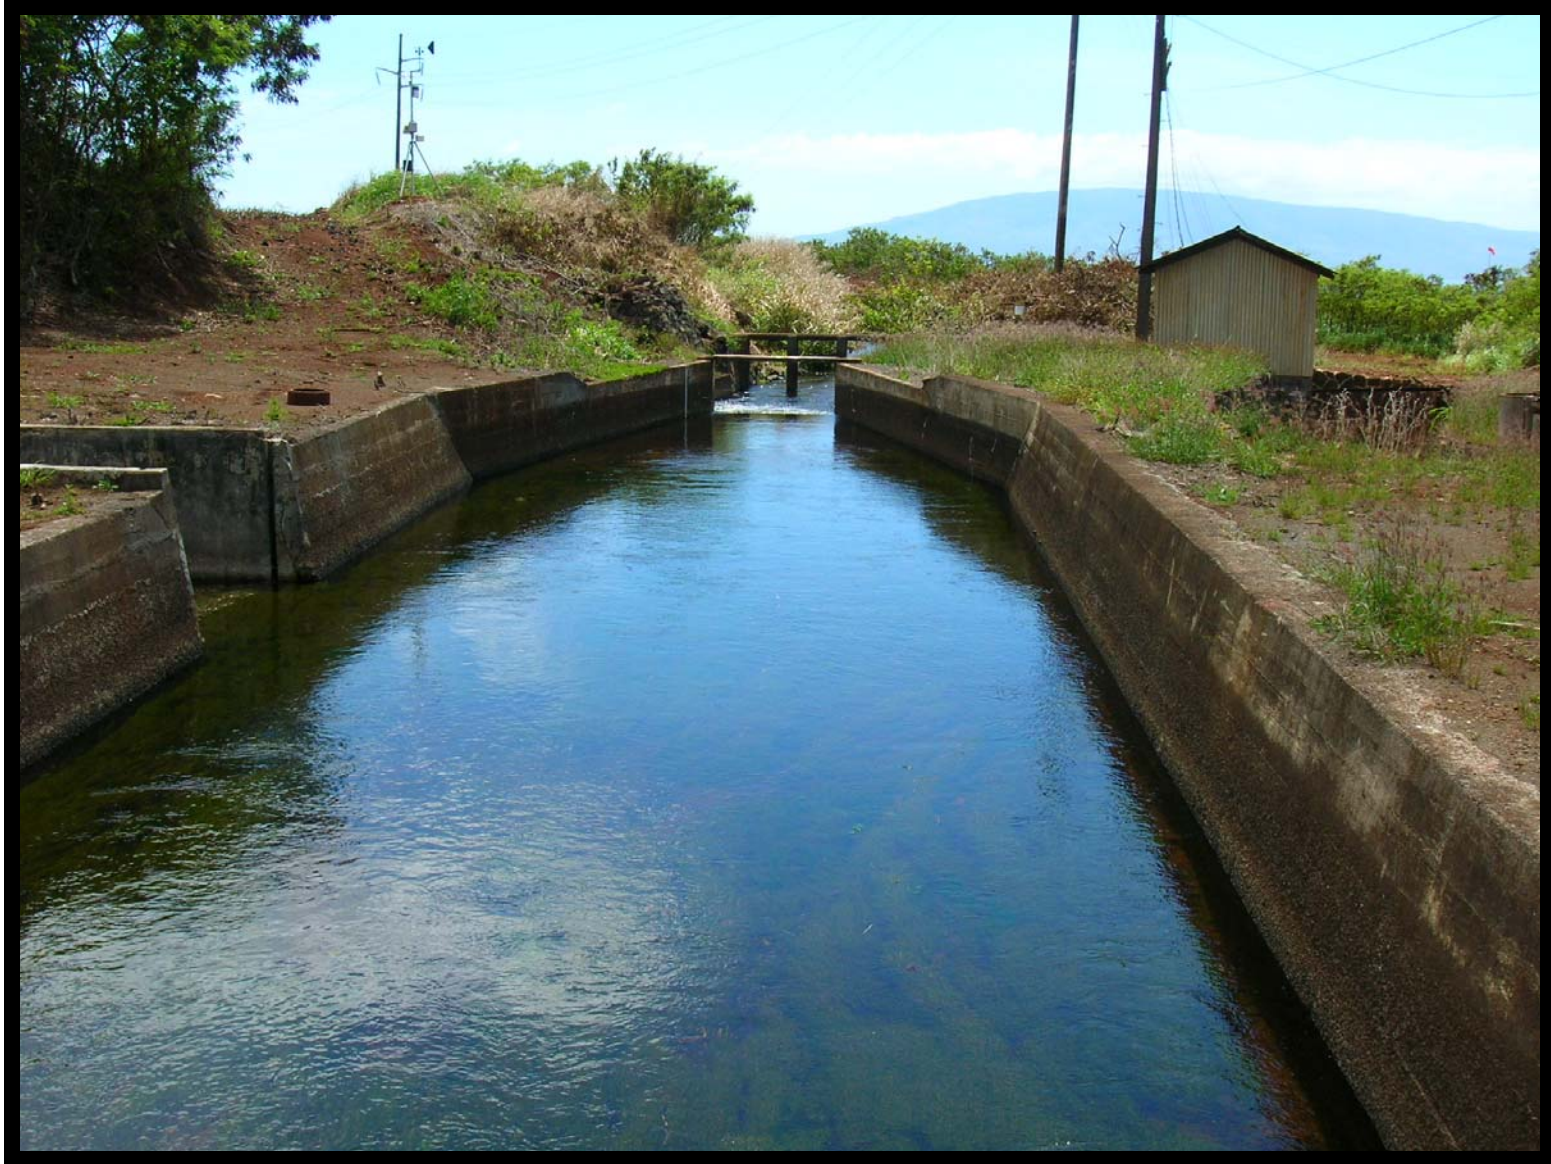
144 Ditch leading from irrigation ditch to the reservoir intake manifold.

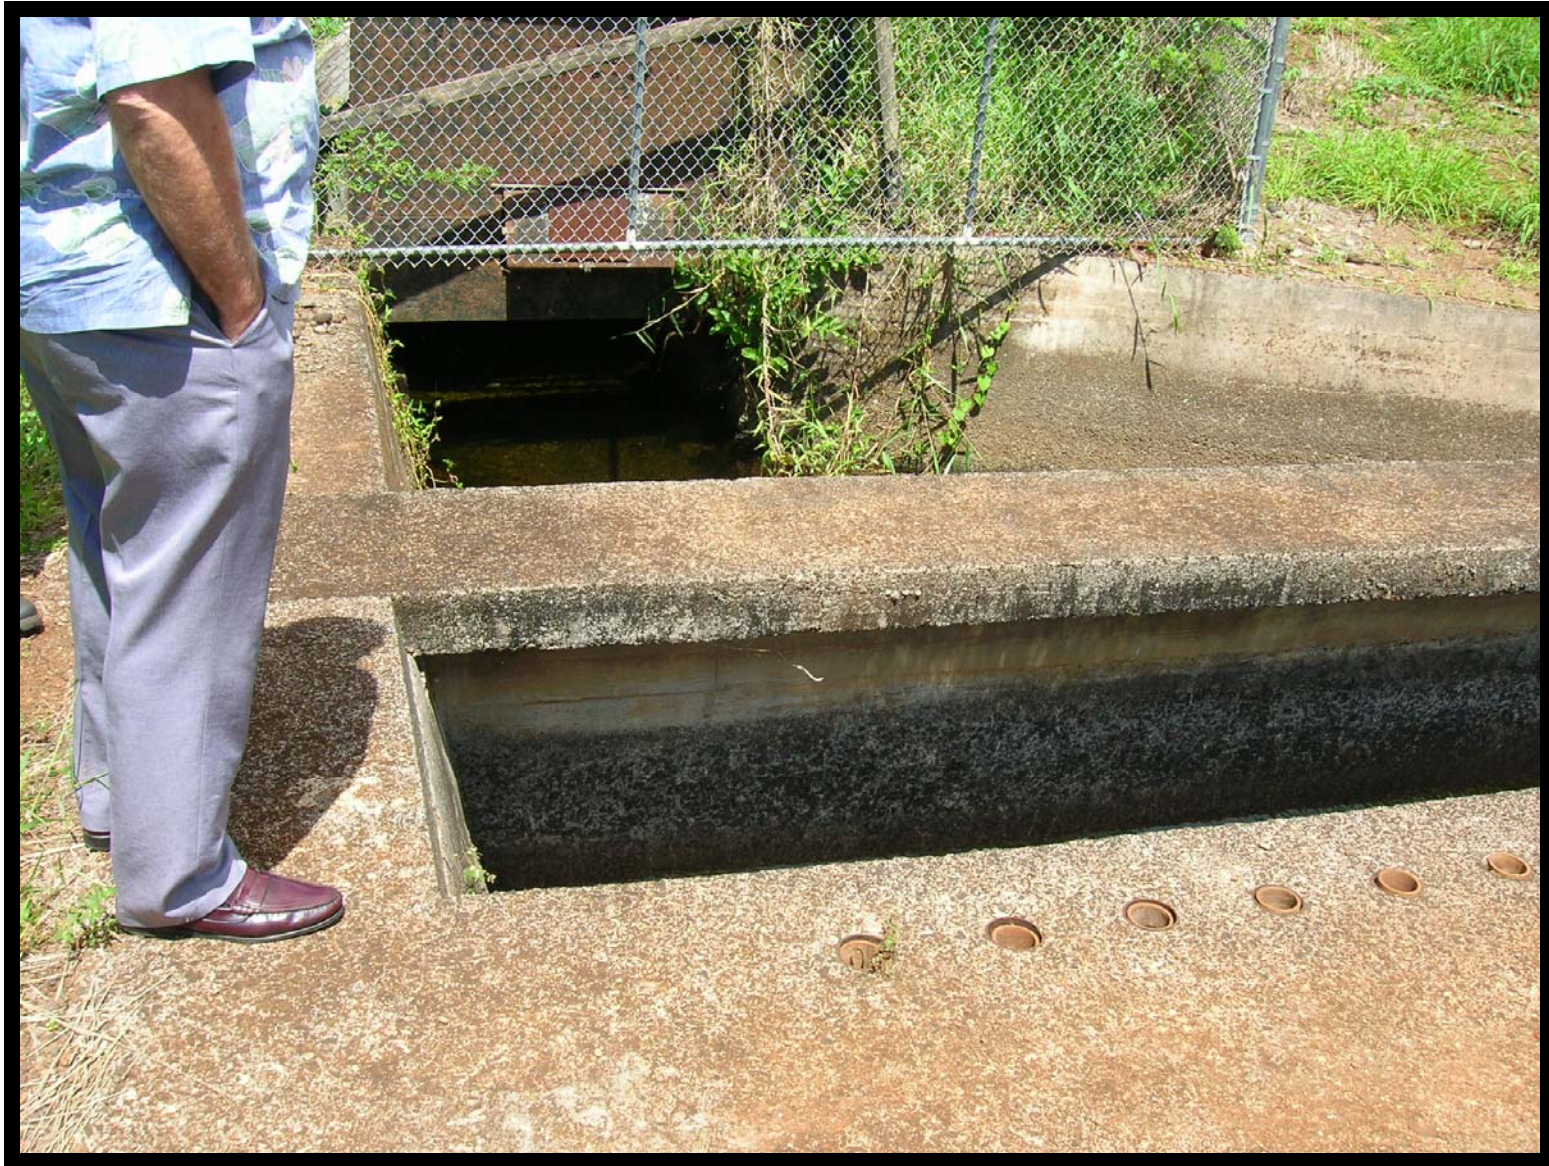
144 Diversion structure at the irrigation ditch upstream of the reservoir.

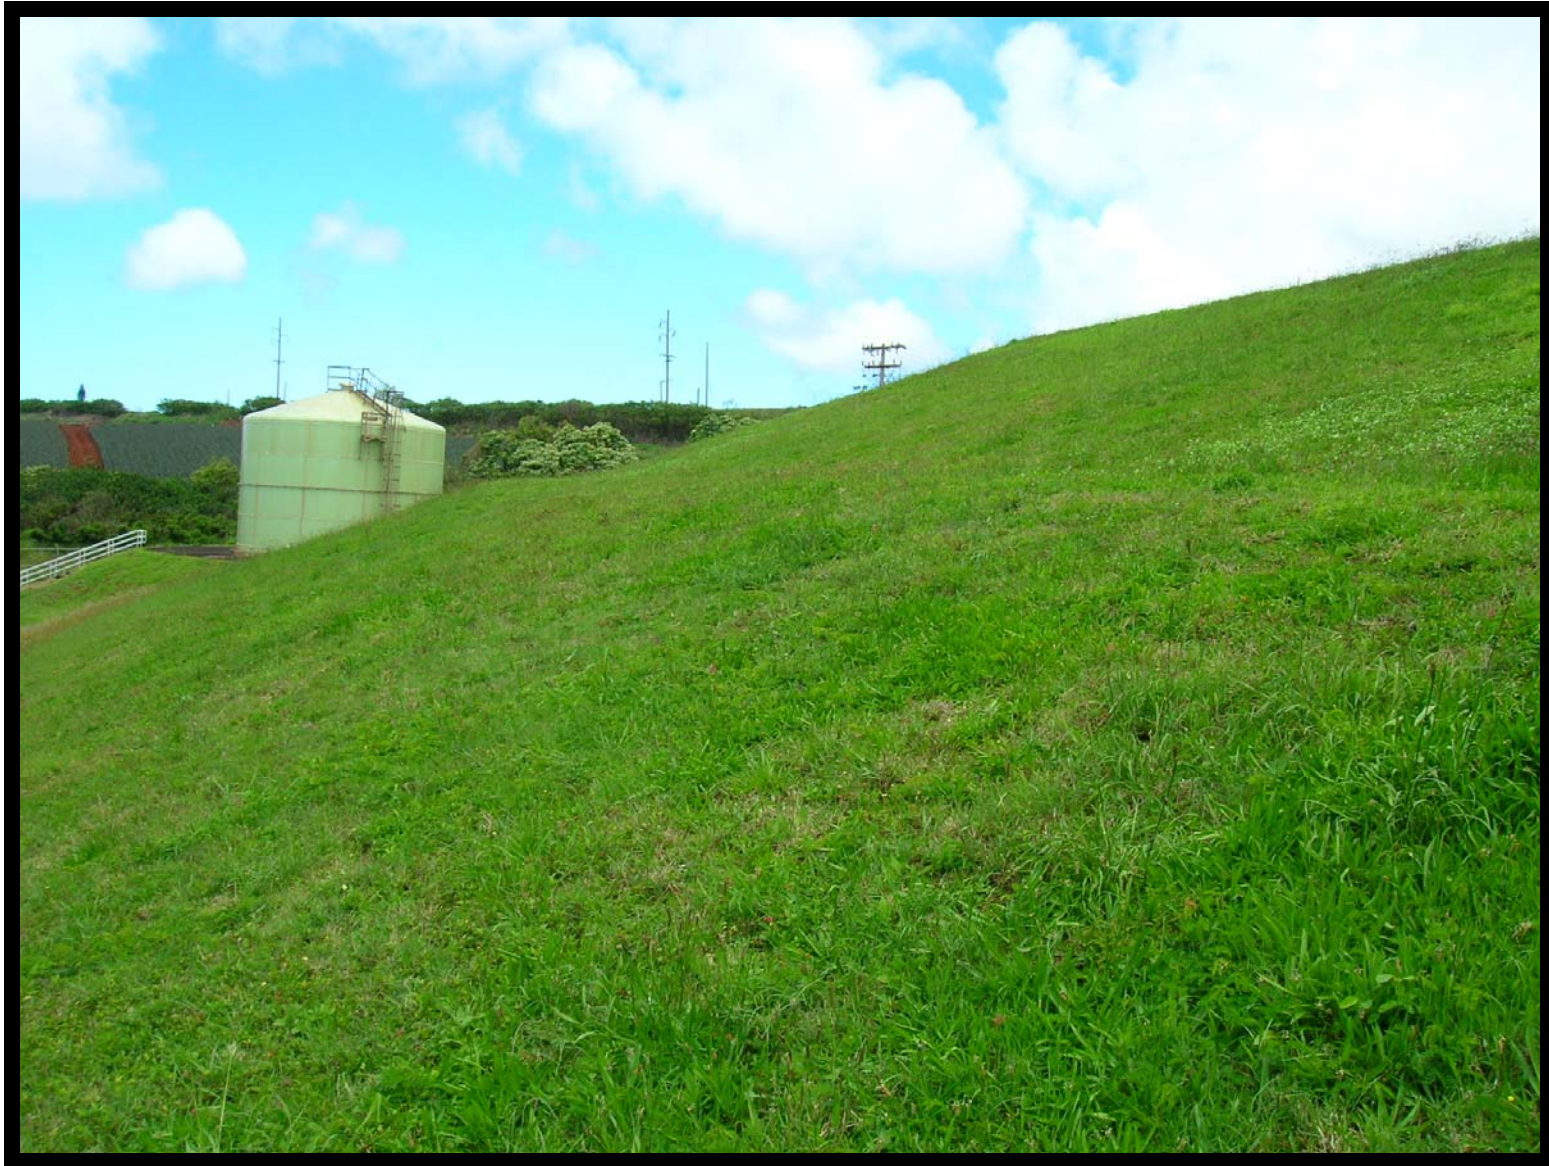
144 downstream - View of the downstream slope of the dam. The slope is covered with short grass. The vegetation condition and management of this section of the slope is excellent.

- 1) The vegetation conditions and west and south side of the embankment and toe and the left abutment were excellent. These areas were covered with short grass and are routinely mowed. The dam owner should continue with their current vegetation management practice on the west and south side of the dam.
- 2) The north side of the dam and right abutment is covered with dense brush and small trees. Visual inspection is difficult. The brush and small trees should be removed and the grass kept short. Mr. Hager informed the inspector that Maui Land and Pineapple Company is responsible for maintaining this segment of the embankment and abutment.

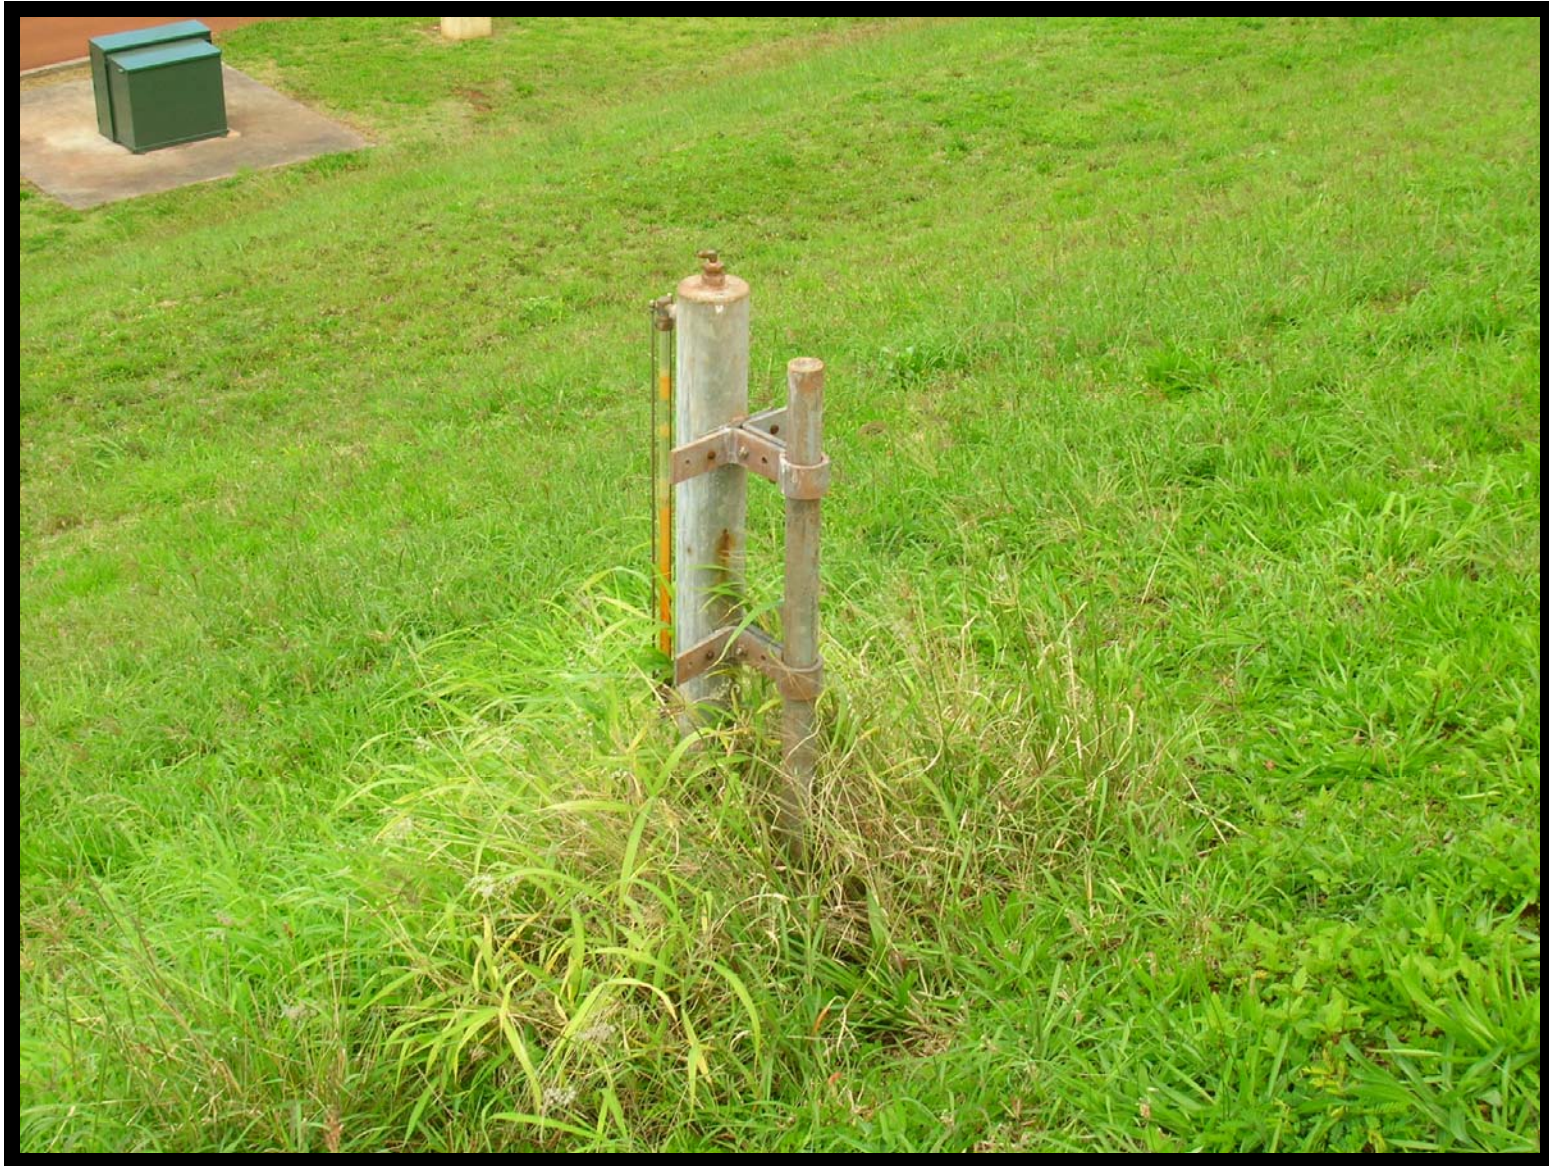
144 gage - View of the staff gage measuring device on the downstream slope of the dam

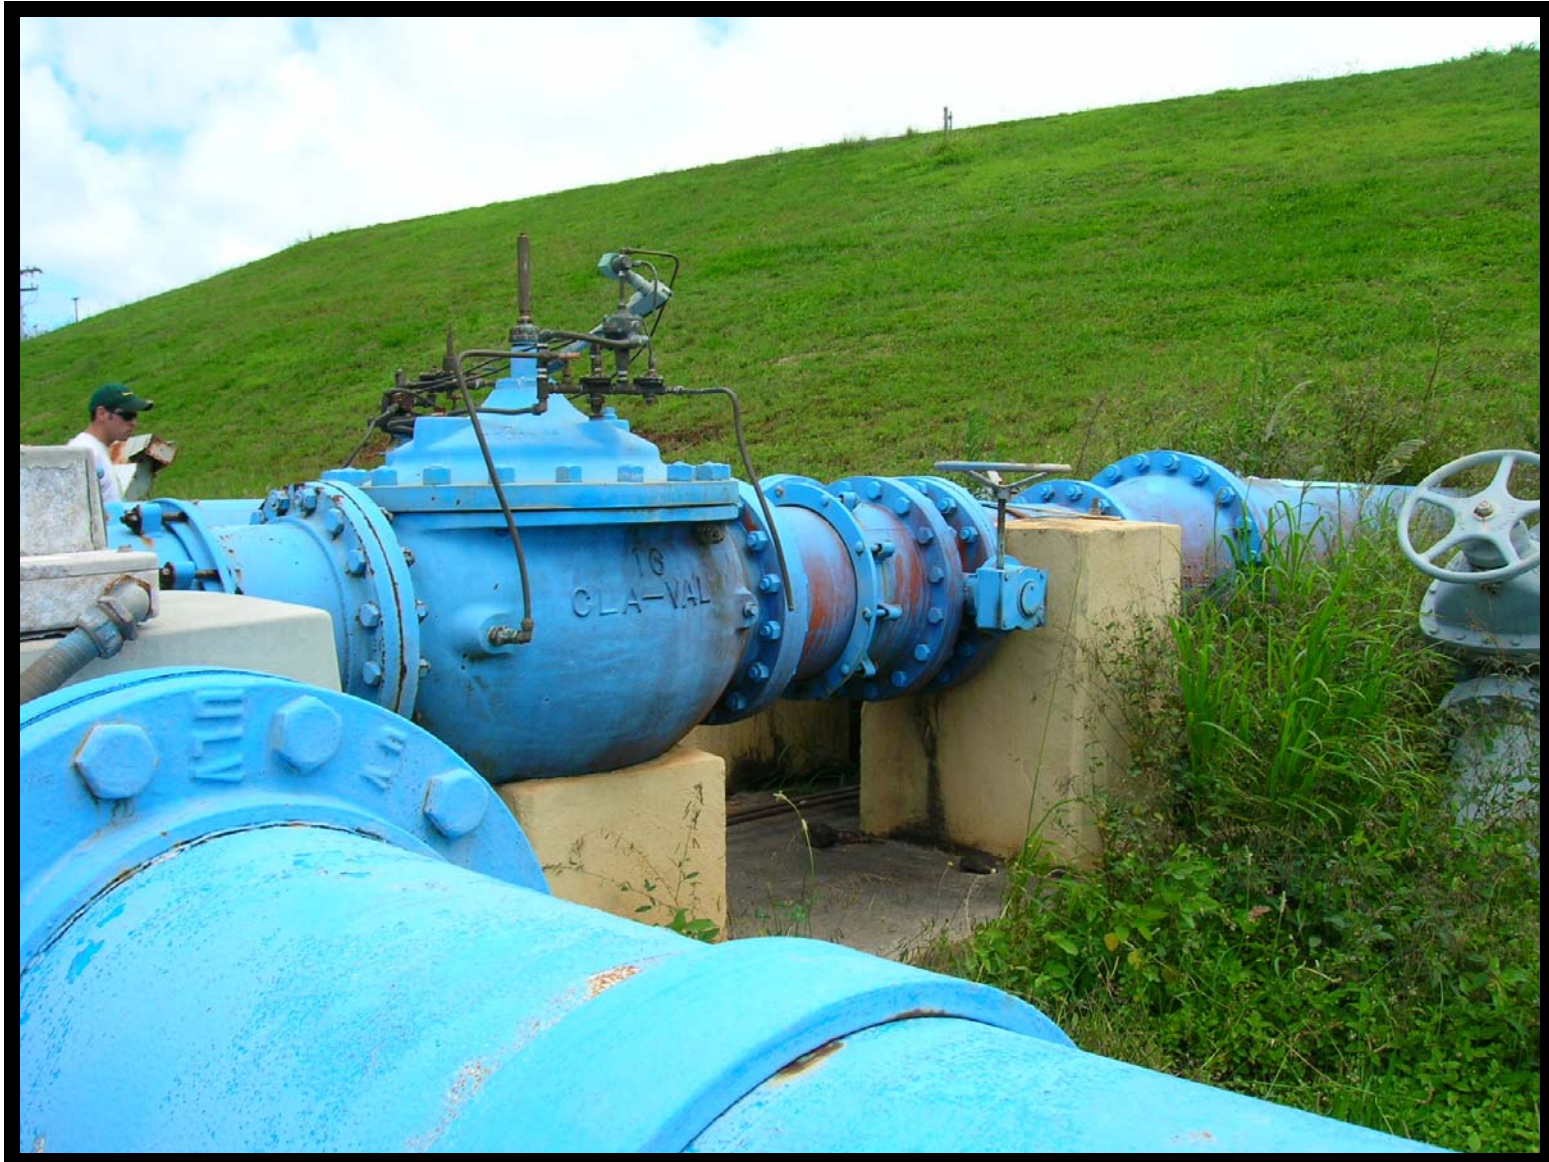
144 intake 1 - View of the reservoir intake manifold. The downstream slope of the dam is in the background.

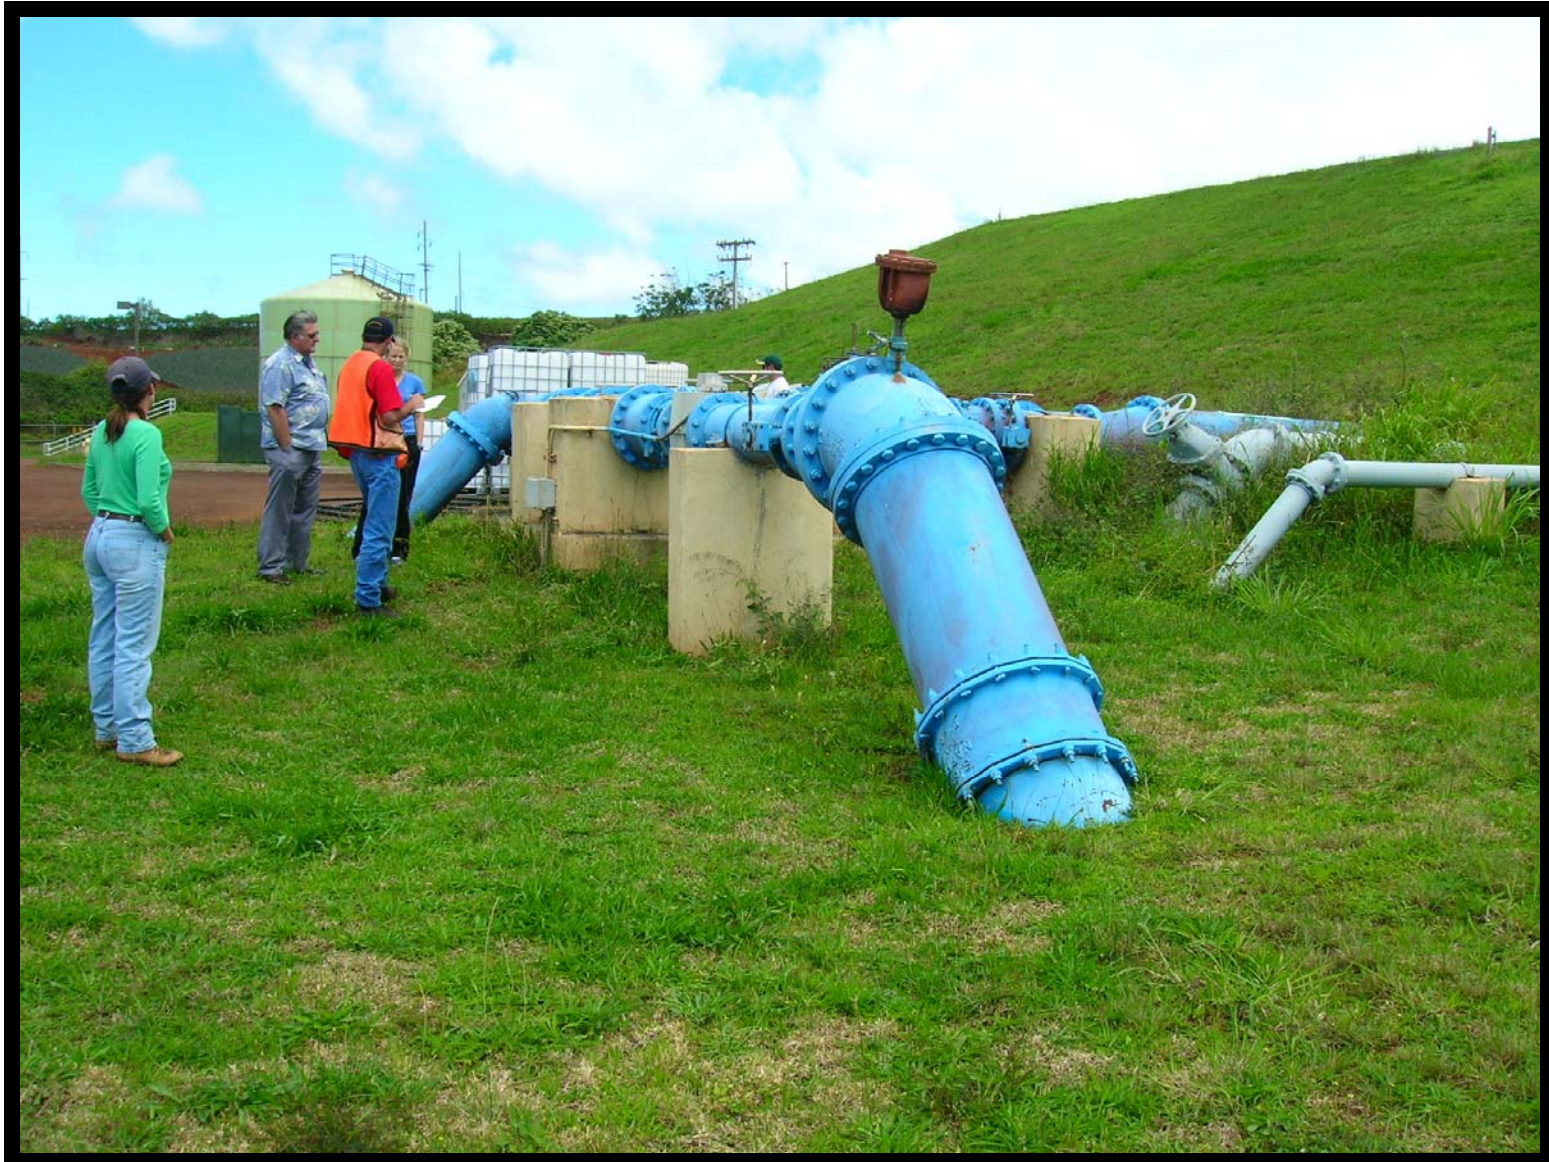
144 intake 2 - View of the reservoir intake manifold. The downstream slope of the dam is in the background.

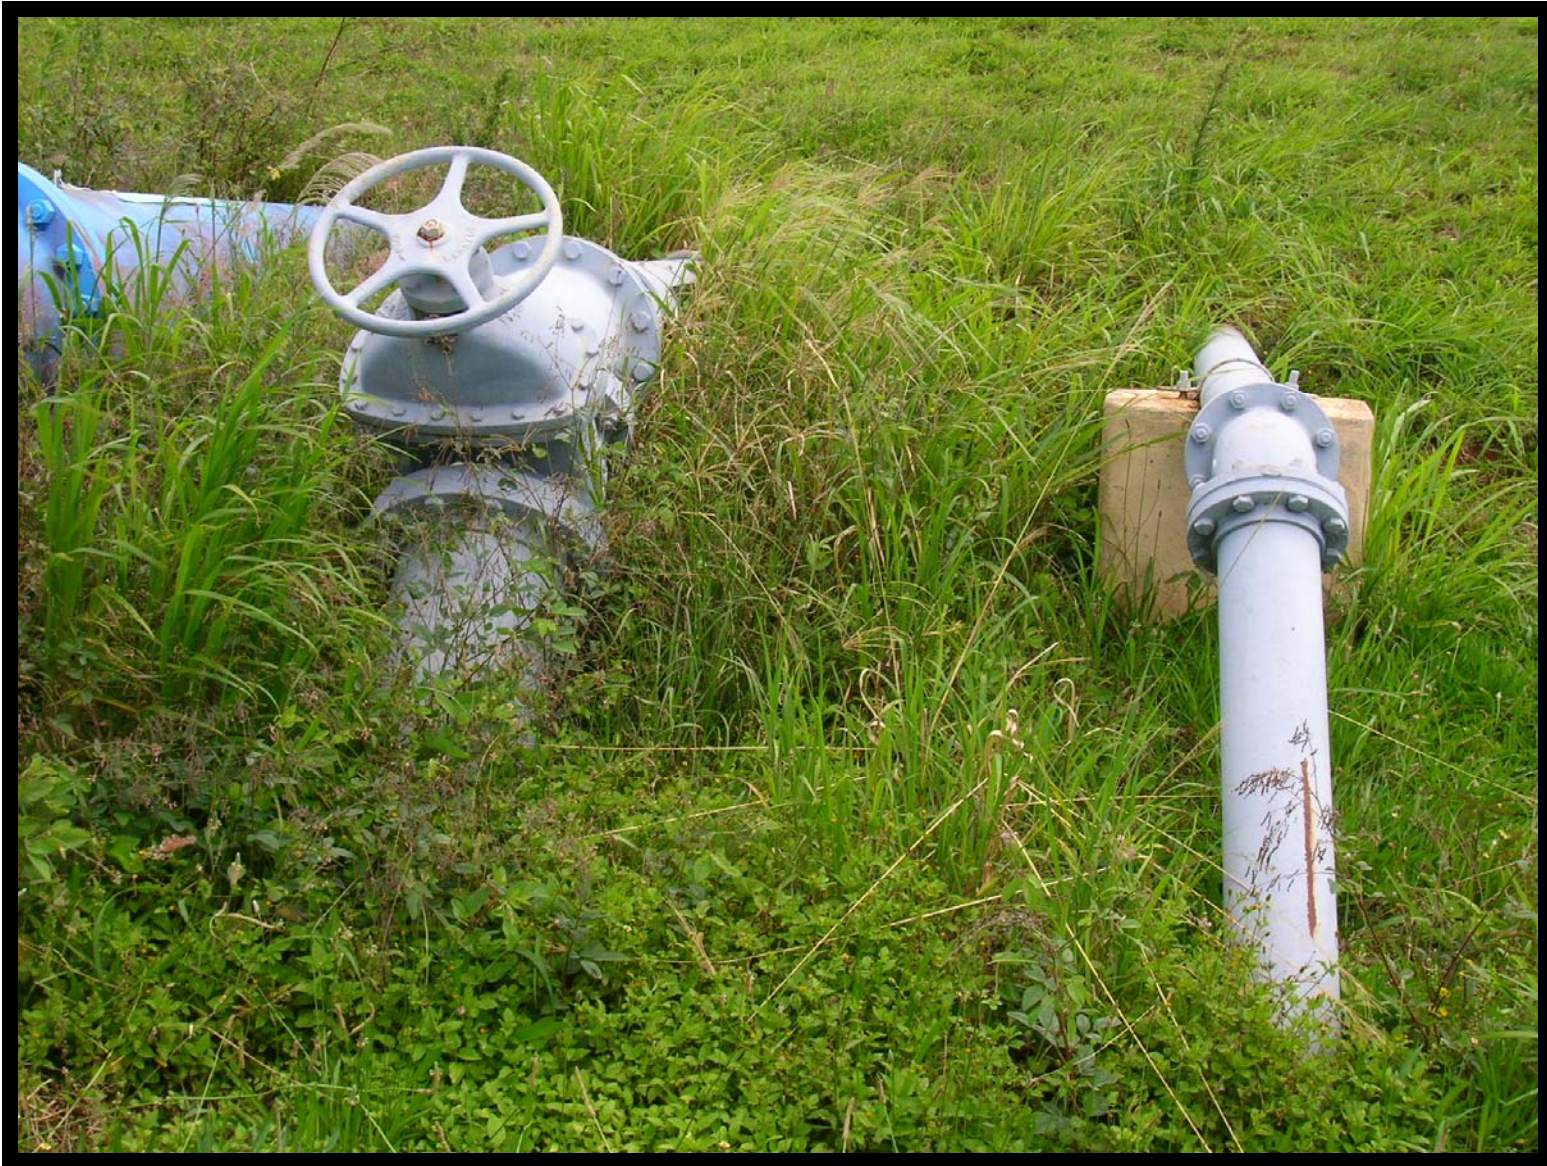
144 outlet - View of the 12" diameter outlet on the left and a 6" diameter inlet on the right.

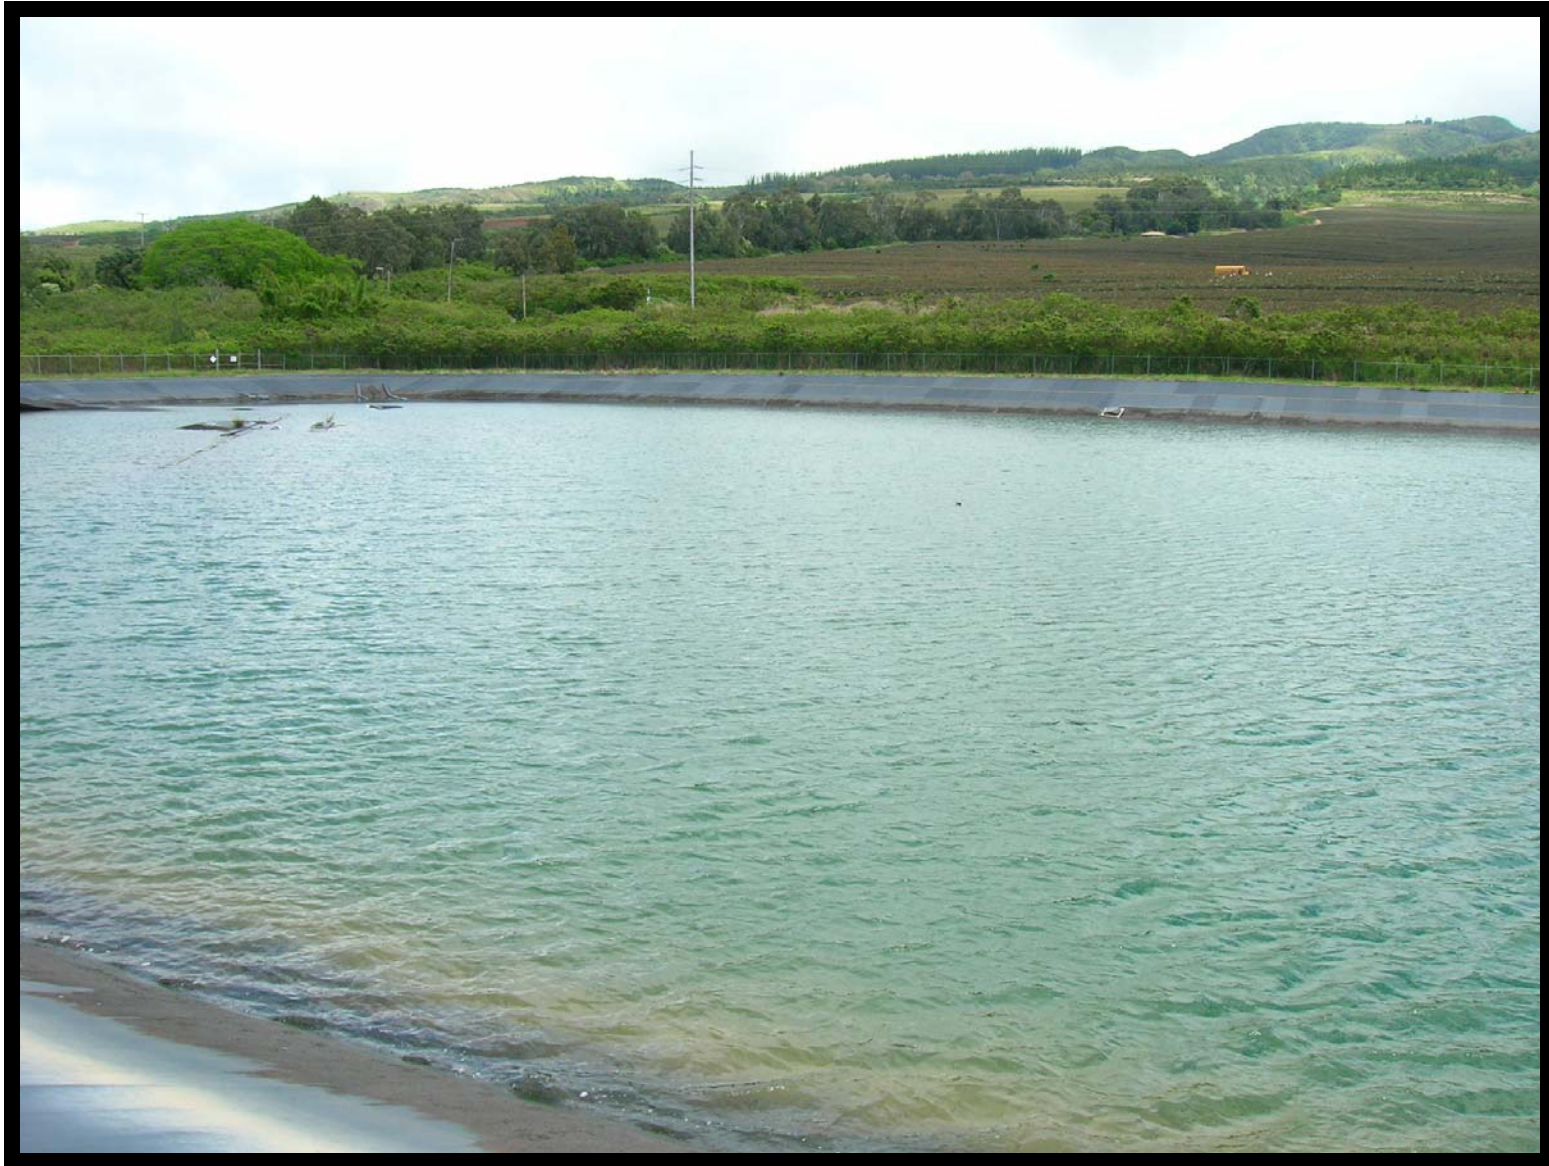
144 reservoir 1 - View of the reservoir. The reservoir is lined with a geomembrane.

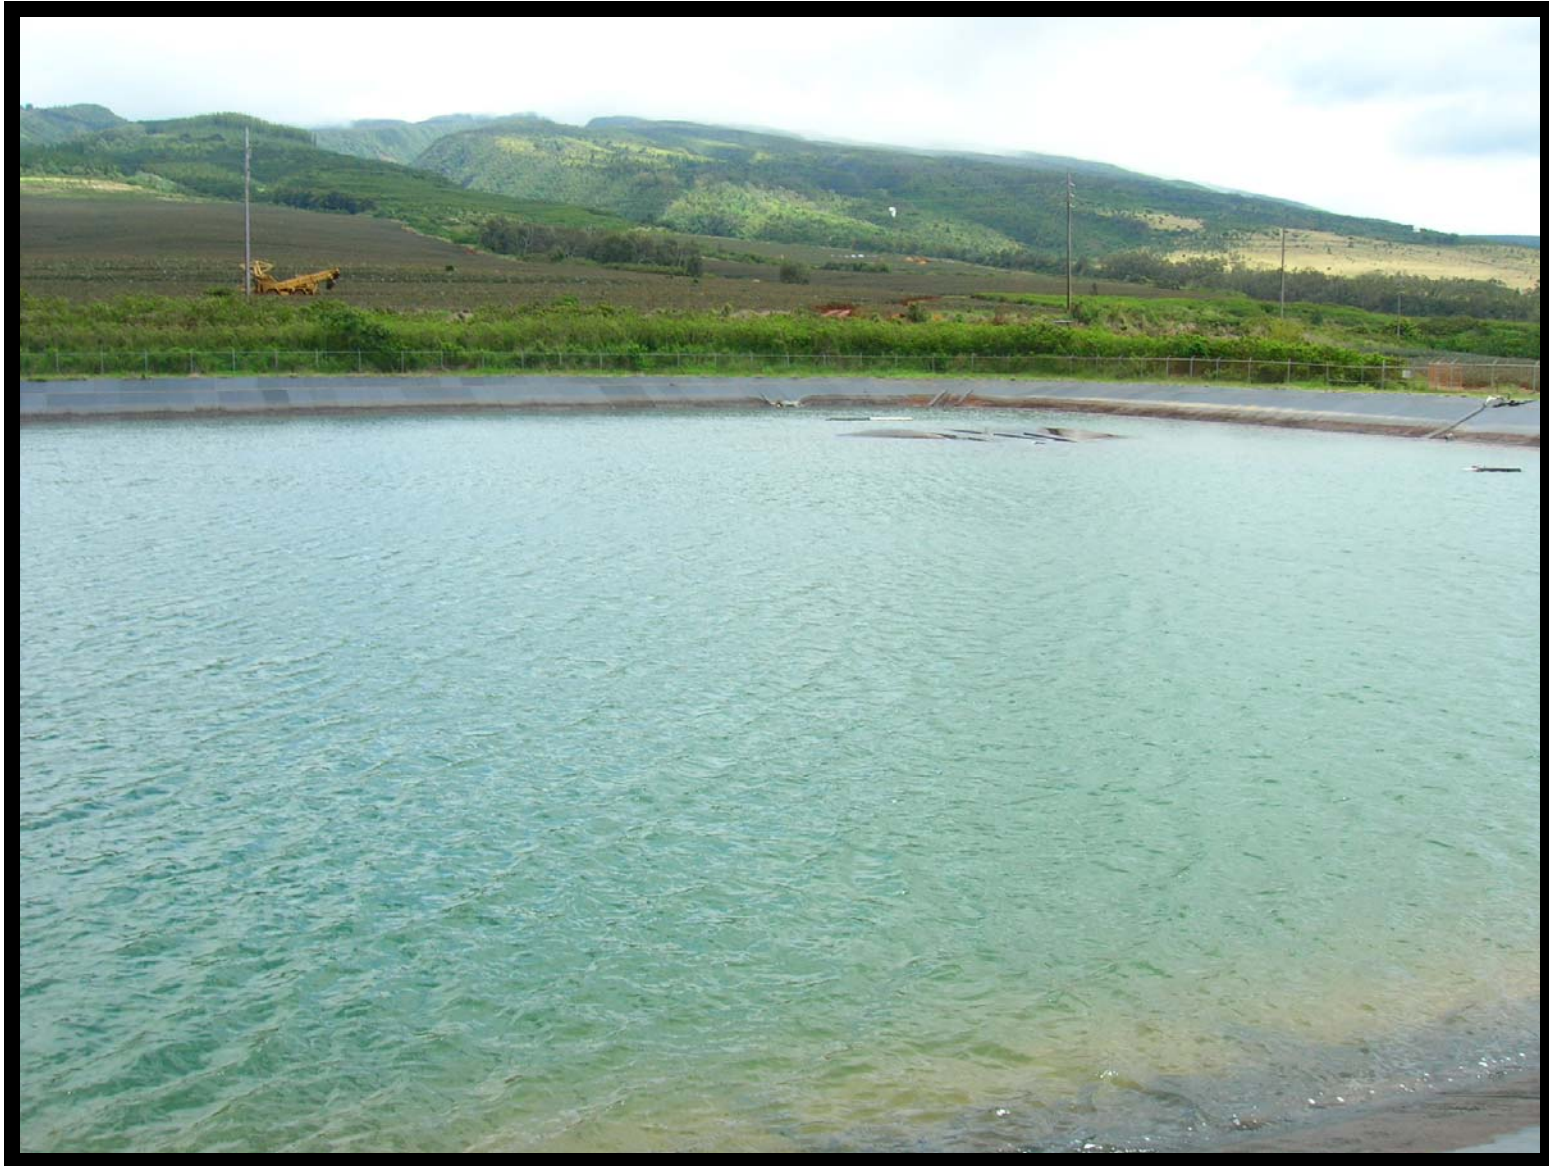
144 reservoir 2 - View of the reservoir. The reservoir is lined with a geomembrane.

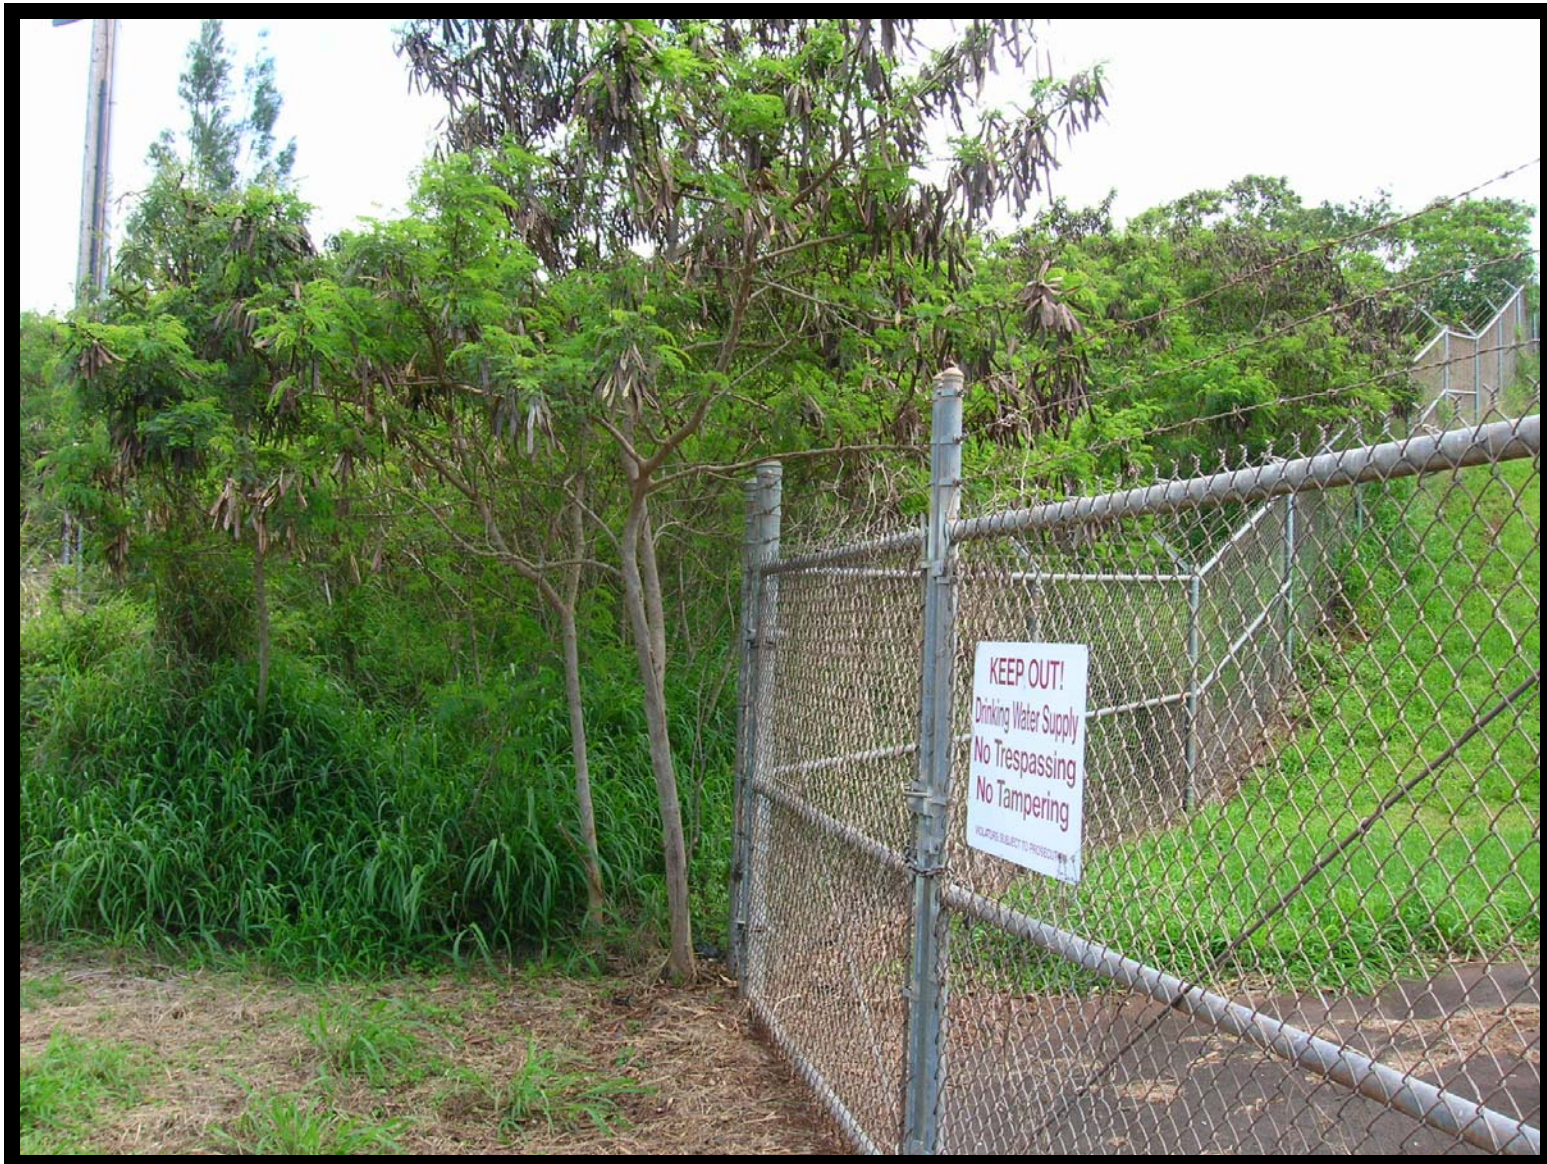
- a. The downstream slope appeared to be in fair to poor condition and requires corrective action.
- b. The downstream slope was not visible due to high grass and bush vegetation. Clear high vegetation and maintain low to enable easy visual inspection.
- c. Tree(s) were observed along the downstream slope. Trees have been identified as the probable cause of piping failures, and can possibly cause severe damage to the embankment if they are uprooted during high winds. Corrective action is required to remove the tree hazards from the dam. Acceptable remedies include removal of the tree and its root structure down to a 2" diameter and reconstructing the damaged embankment section. All repair work shall be accomplished as per the requirements of a licensed geotechnical or structural engineer. Routinely monitor the damaged area for signs of settlement and seepage.

144 slope veg 1 - Dense brush and small trees located on the downstream slope on property that is maintained by Maui Land and Pineapple, LLC. The brush and trees should be removed and the grasses kept short.

- a. The abutments/toe appeared to be in fair to poor condition and requires corrective action.
- b. The abutment/toe area was not visible due to high grass and bush vegetation. Clear high vegetation and maintain low to enable easy visual inspection.
- c. Corrective action only for the toe and right abutment on Maui Land and Pineapple Co. maintained property.

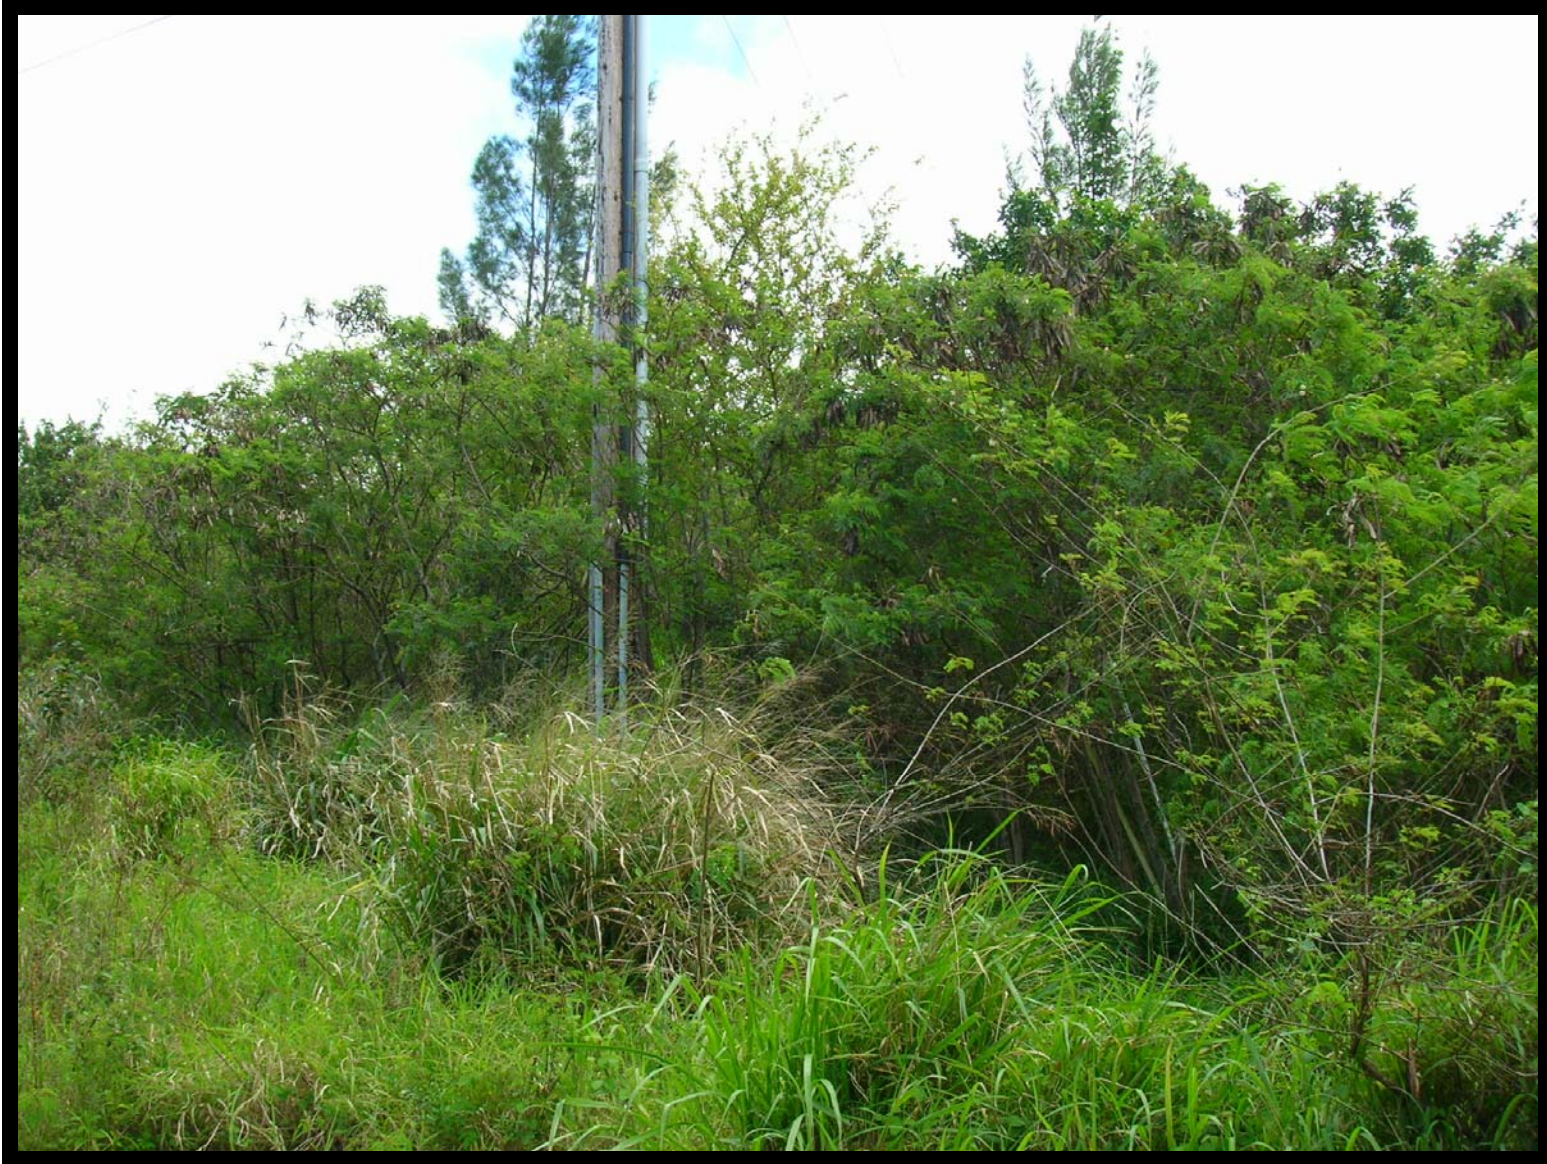
144 slope veg 2 - Dense brush and small trees located on the downstream slope on property that is maintained by Maui Land and Pineapple, LLC. The brush and trees should be removed and the grasses kept short.
